Navajo Abandoned Uranium Mine

Site Screen Report

Ryan No. 1 AUM Site

January 2011

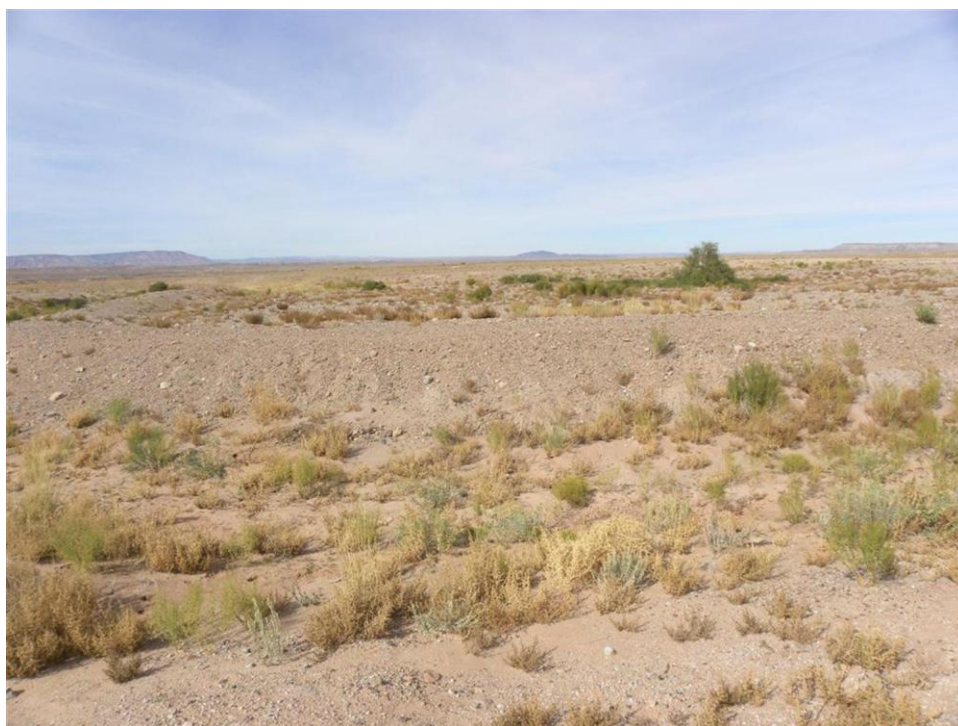
Photo 2. Ryan No. 1 mine site, berm area

Soil/rock berm diverting drainage around the center of the site

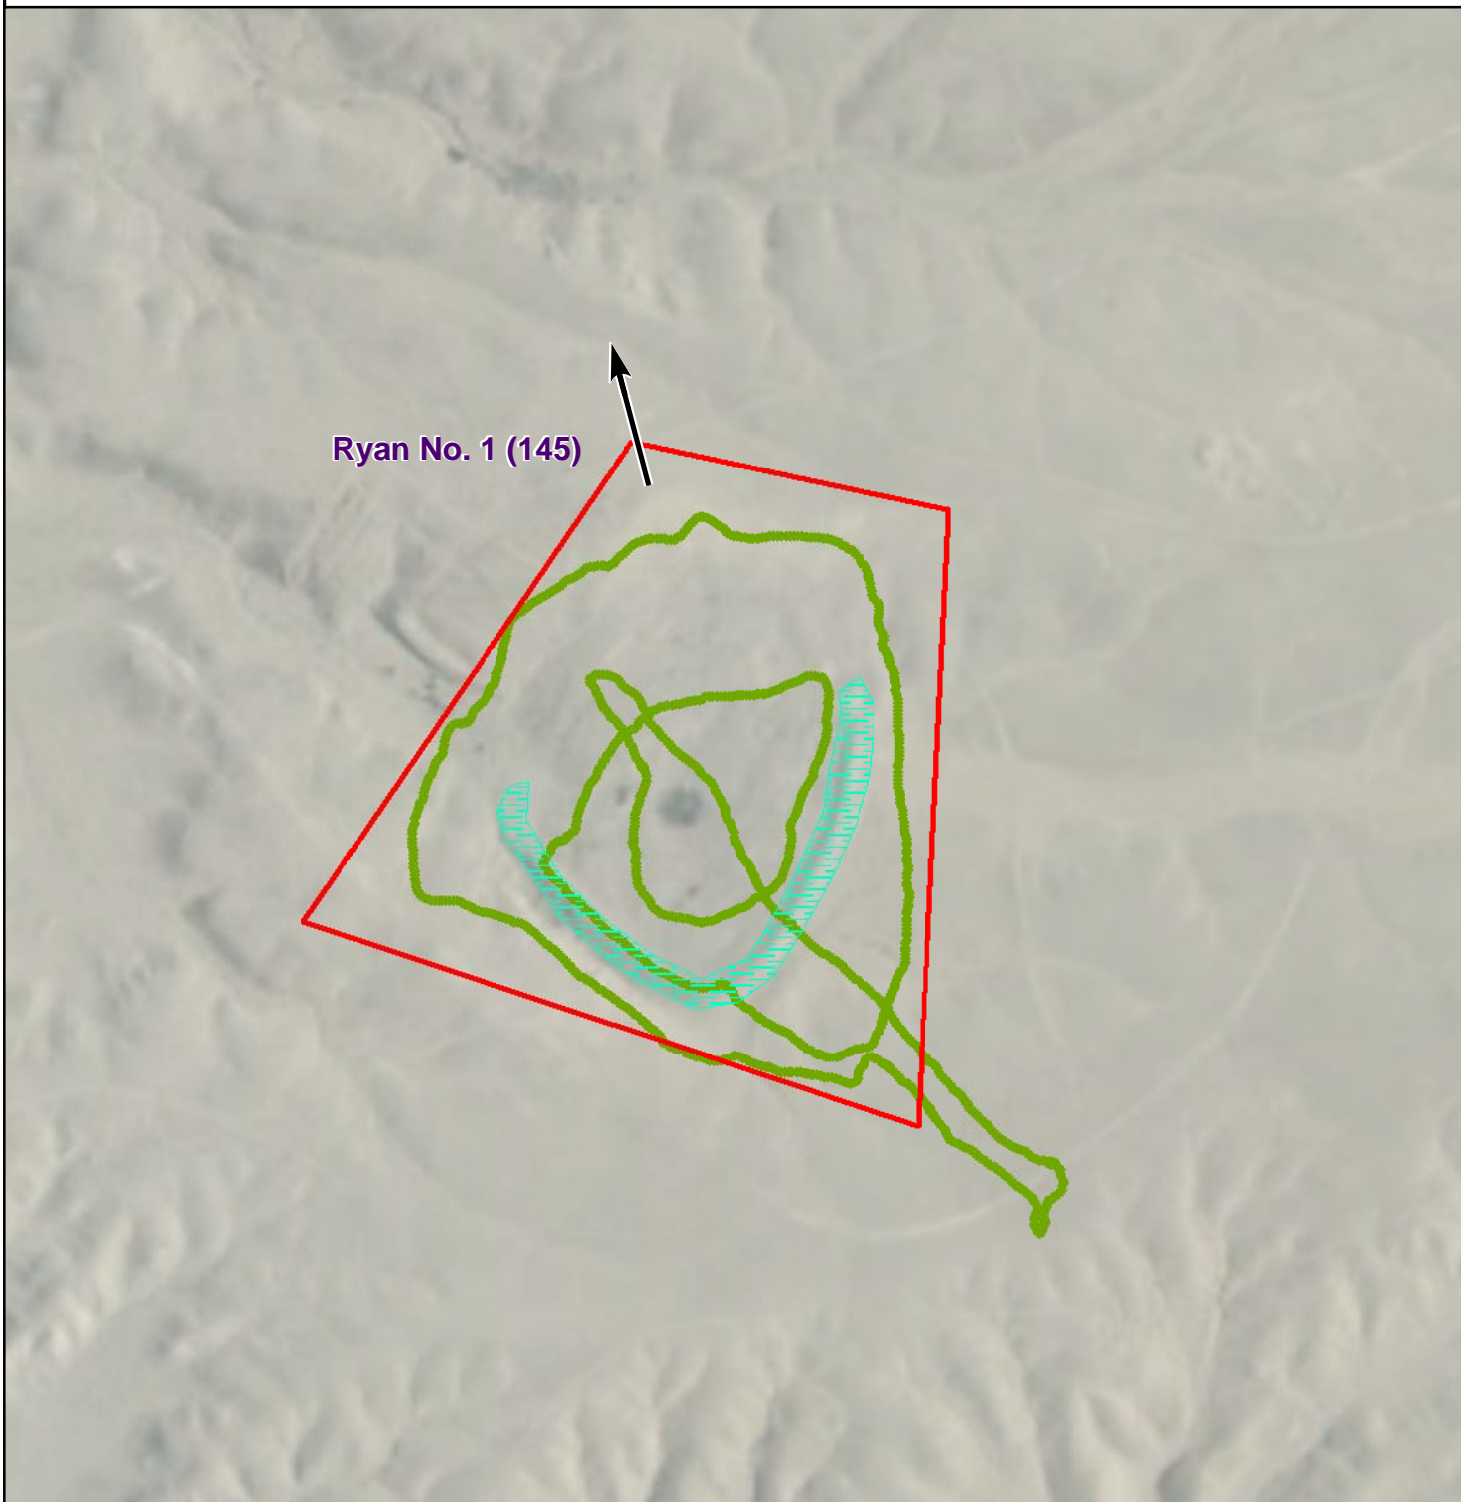
**Figure 1 - Gamma Radiation Measurements, Above Two Times Background
Ryan No. 1 (145)
Coalmine Mesa Chapter, Navajo Nation**

A total of 1,228 gamma radiation measurements were collected from the mine site, ranging from 6,744 cpm to 16,775 cpm. The measurements are represented in Figures 1 and 2.

Gamma survey conducted 11/2010
Measured as counts per minute (cpm)

Average background 10,160 cpm
